Operation and Maintenance Report  
January 2019 to December 2019

## McCormick and Baxter Superfund Site

Portland, Oregon  
ECSI Site No. 74

**July 22, 2020**  
**150-002-005/Task 3**

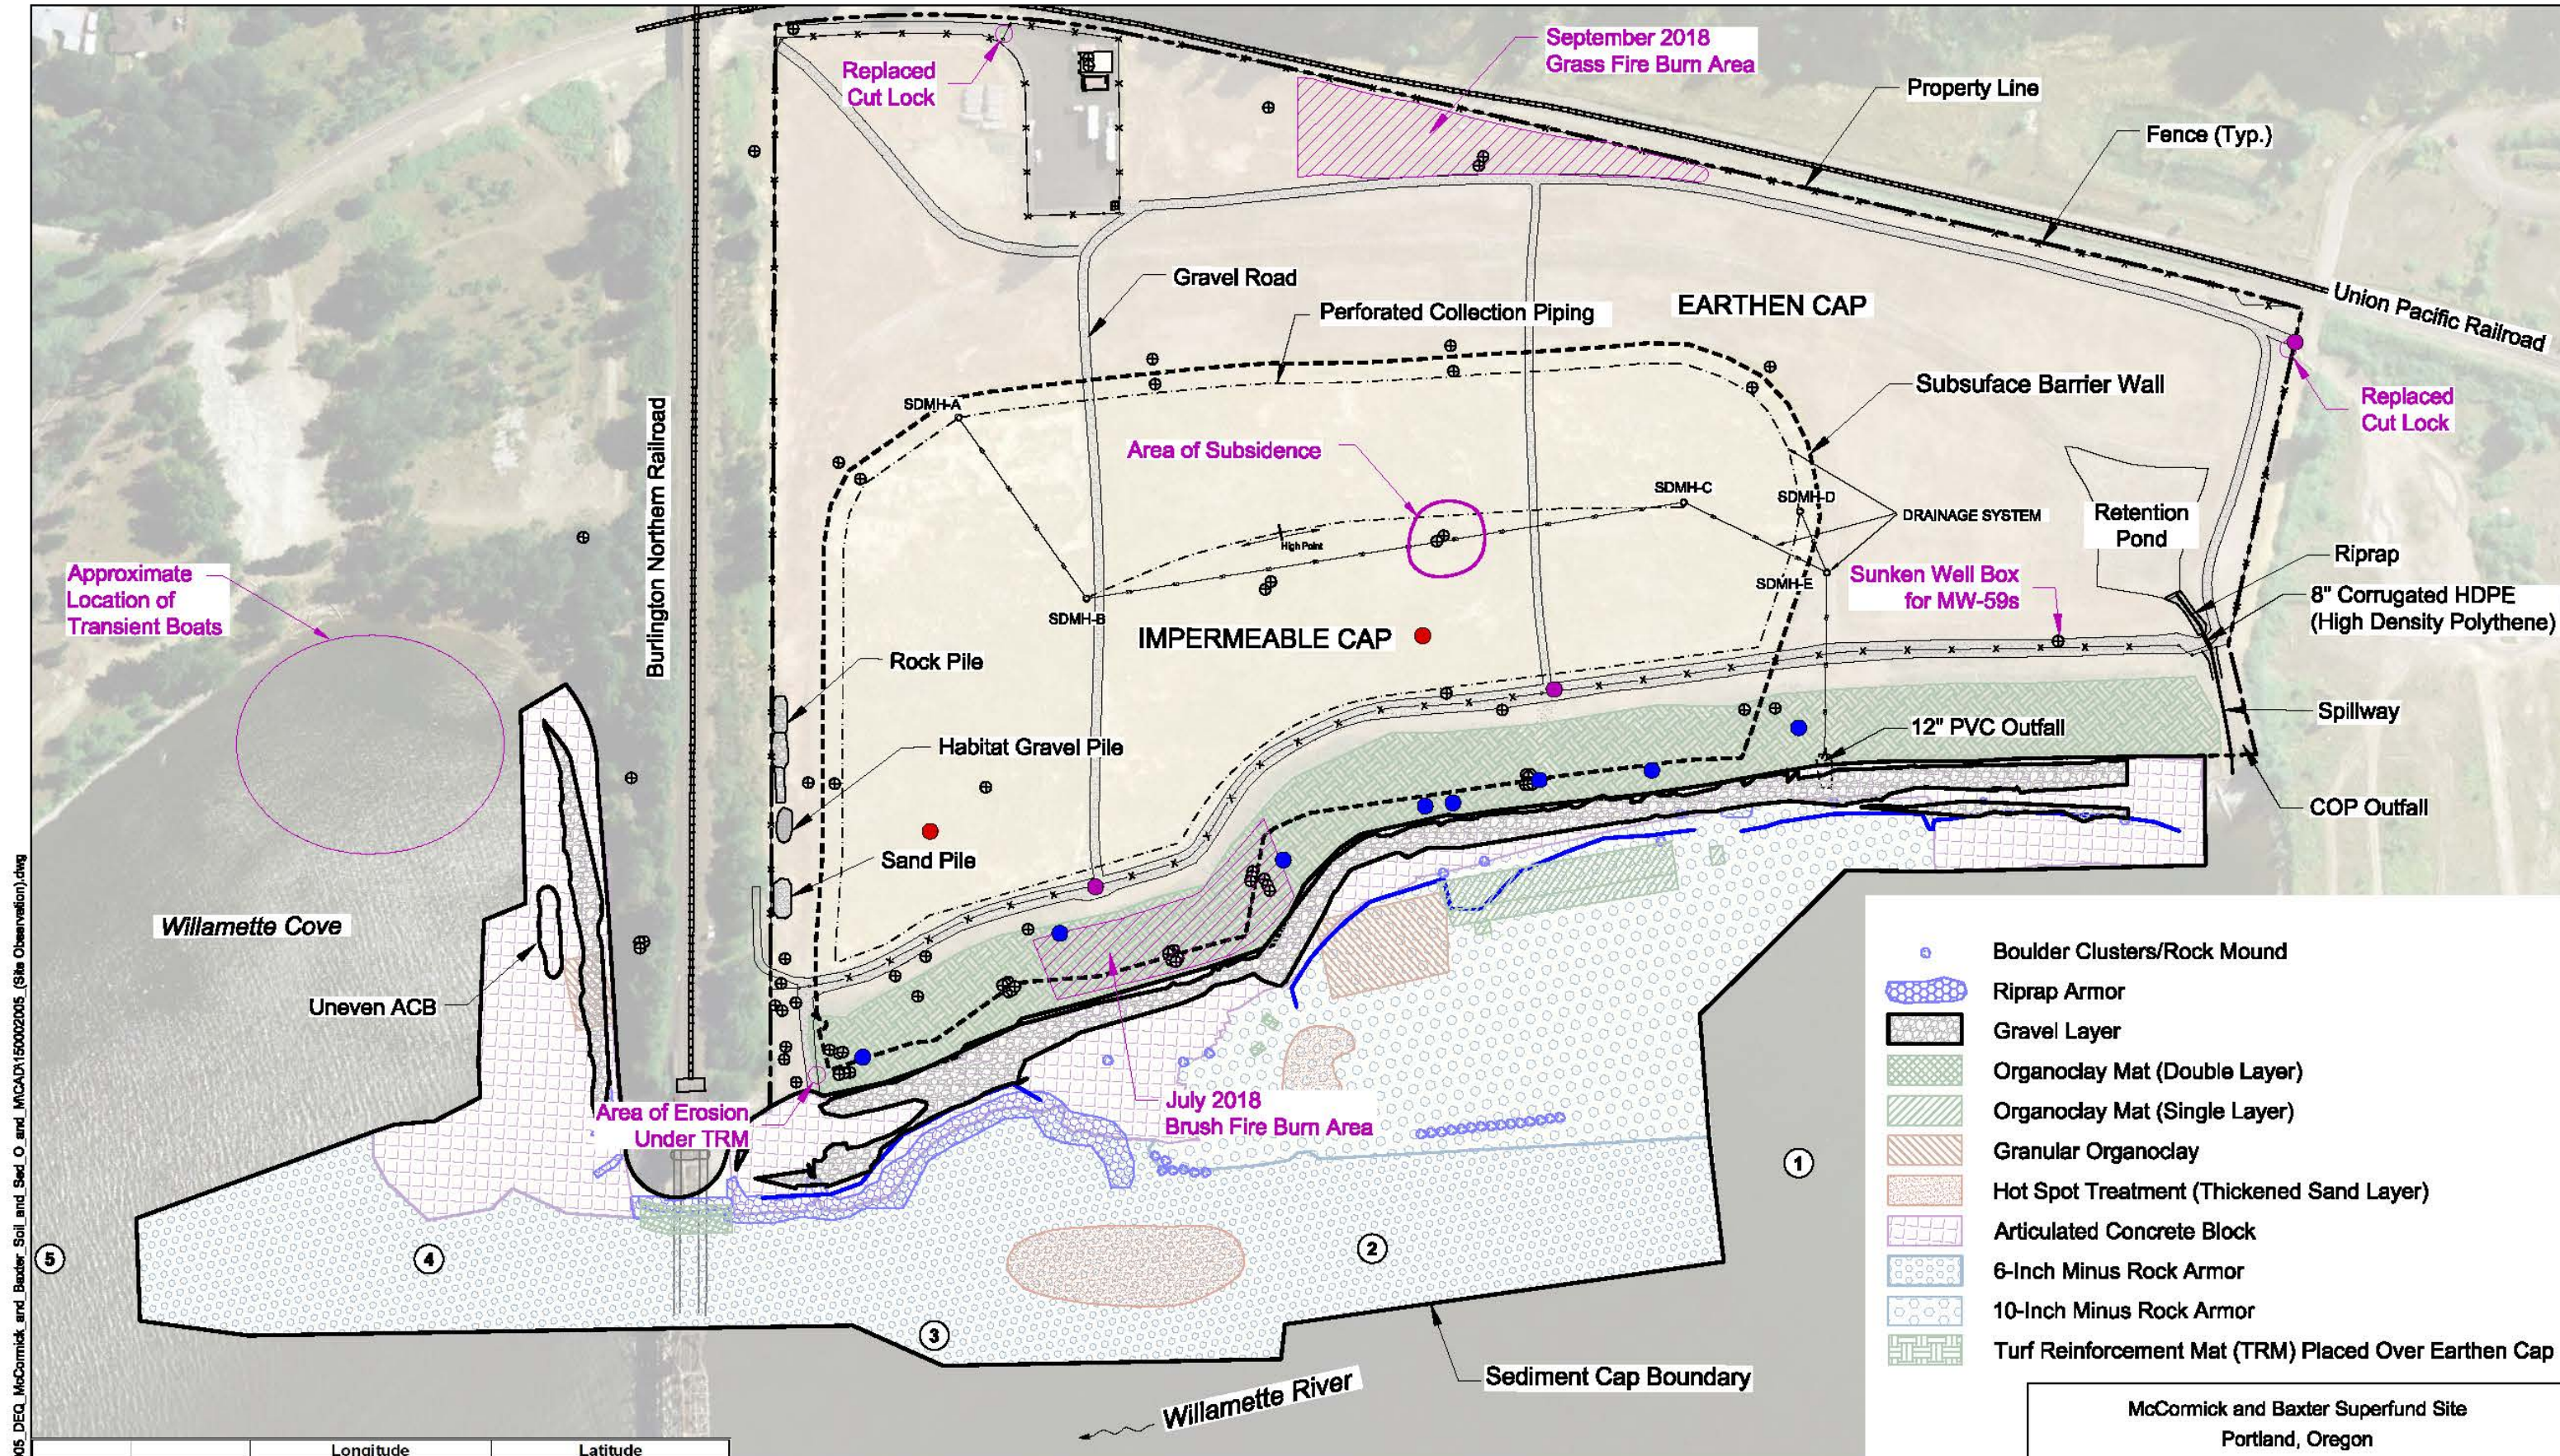
Figure  
2-1

On July 18, 2018, a fire burned approximately 1 acre at the northwestern end of the riparian area between monitoring wells MW-39s and MW-43s (Figure 2-1). The fire primarily burned brush and grass undergrowth impacting the riparian area closer to the river (Appendix A, Photograph A3). Vegetation regrowth was monitored throughout 2019. Grass regrowth along the shoreline was complete by the July 2019 site inspection (Appendix A, Photograph A13) with visible signs of the fire, including only burned driftwood tree trunks and charred tree branches. The majority of trees within the burned area survived

On July 19, 2018, a fire burned approximately 1 acre at the north end of the riparian area as shown in Figure 2-1. On September 24, 2018, another fire burned approximately 1 acre along the northeast side of the site, approximately 200 feet southeast of the site maintenance building and along the inside of the fence line. Vegetation recovered in these areas by July 2019.

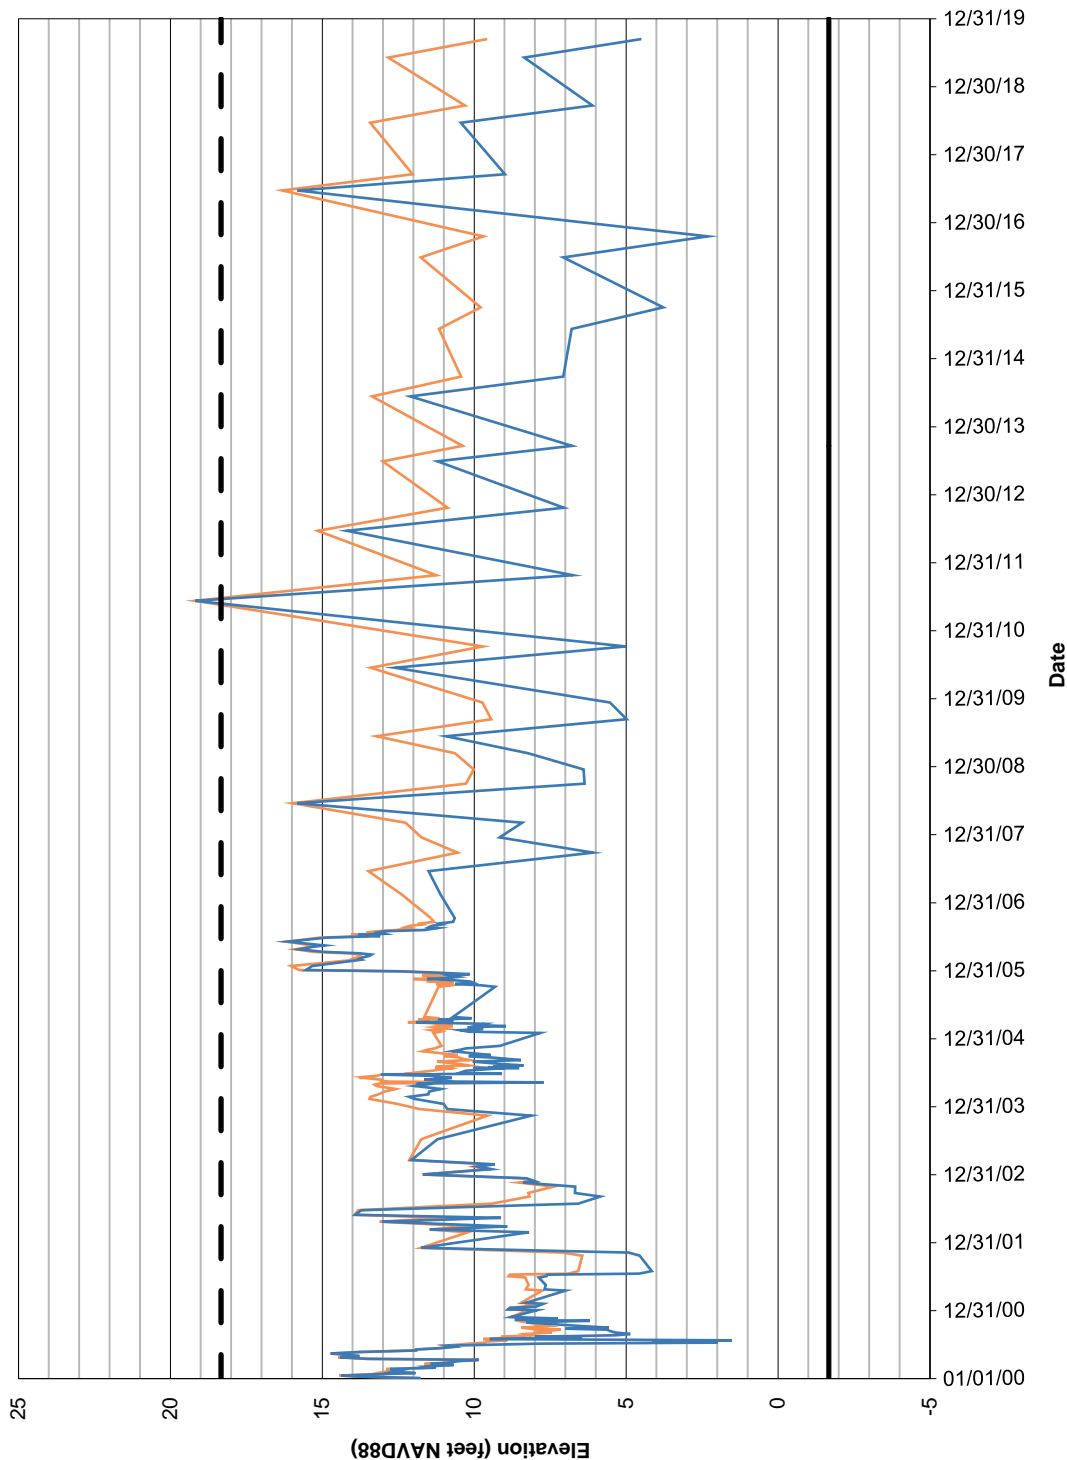
**FIGURE 4-17**

**2009 to 2019 NAPL Thickness Plot  
for Well EW-1s**  
McCormick and Baxter Superfund Site  
Portland, Oregon

Ground subsidence has been observed in the vicinity of EW-1s and the well casing has sunk over time. The screened interval and total well depth have been referenced to the most recent ground survey from September 2009. Given that the elevations are changing with time, the elevations shown are approximate.

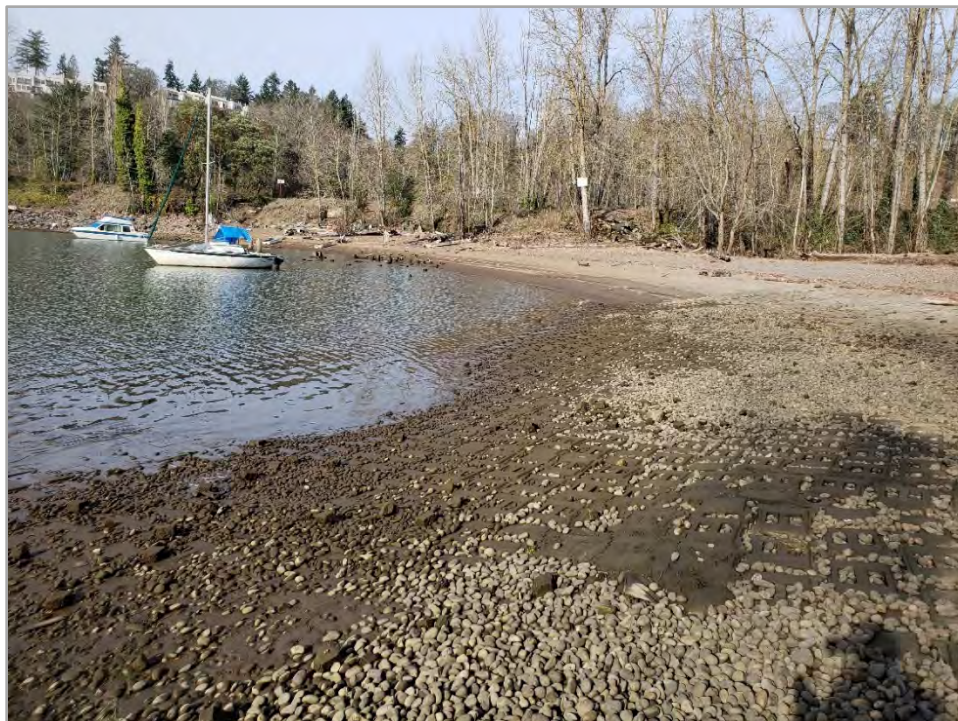
**Photograph A1:** View facing north of Willamette Cove shoreline and derelict boats anchored within the cove (February 2019).

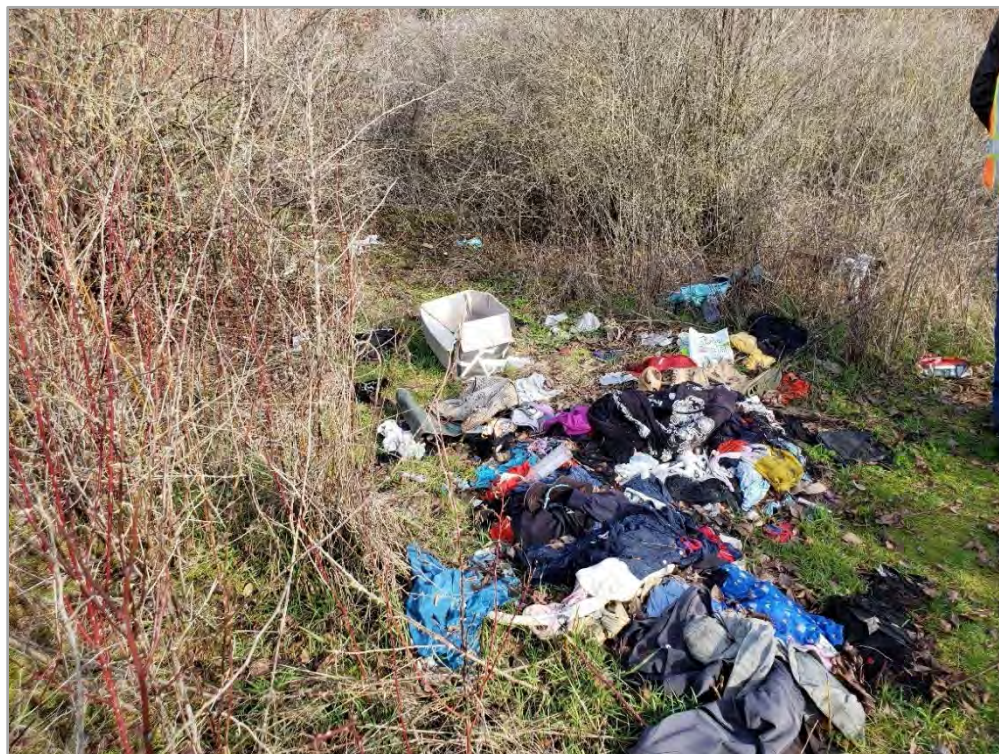
The shoreline along the site and Willamette Cove is publicly accessible and used for various forms of recreation. Transient encampments were not observed along the Willamette River shoreline; however, eight dumpsites were observed along the entire length of the shoreline during the February 2019 site inspection (Figure 2-1, Appendix A, Photograph A2). Hart Crowser coordinated with Metro to remove the trash and debris from the dumpsites in March 2019.

**Photograph A2:** One of several dumpsites for trash in the riparian area along the Willamette River (February 2019).

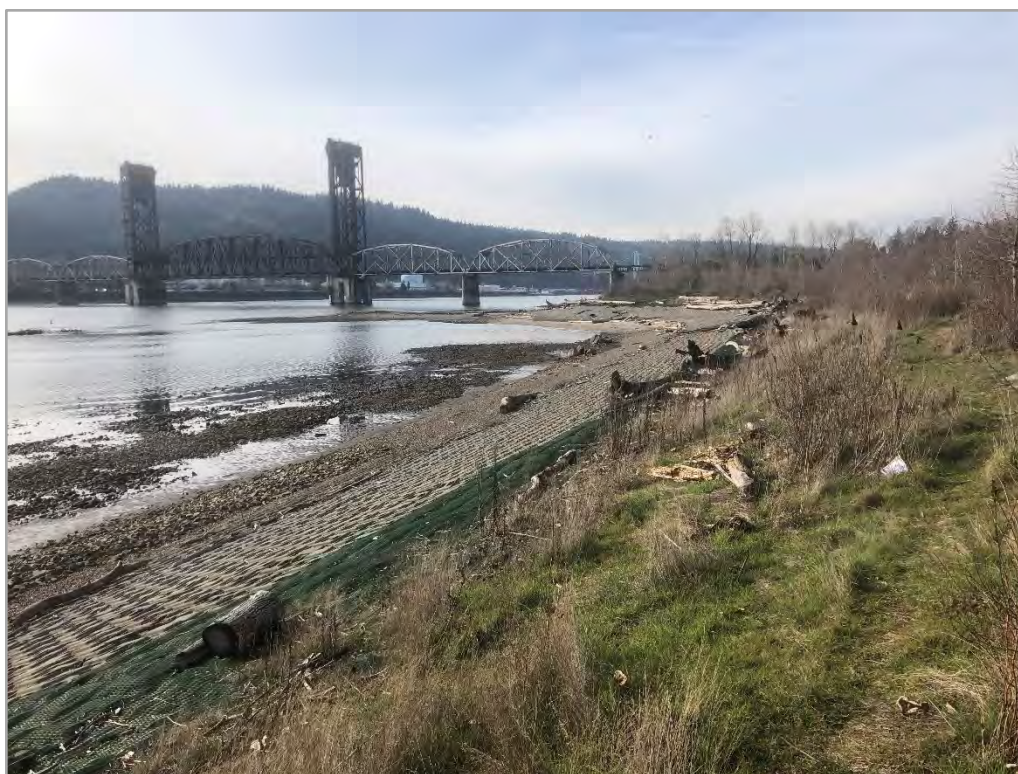
**Photograph A4:** Shoreline conditions along the Willamette River (February 2019).

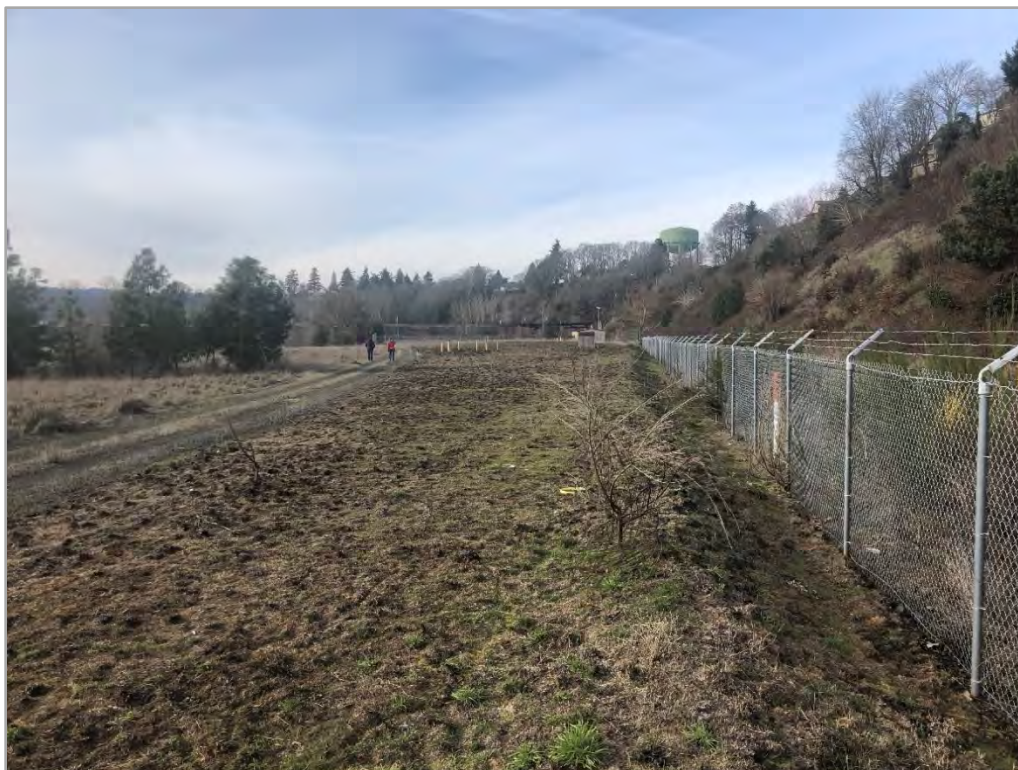
**Photograph A5:** View facing north of September 2018 grass fire burn area (February 2019).

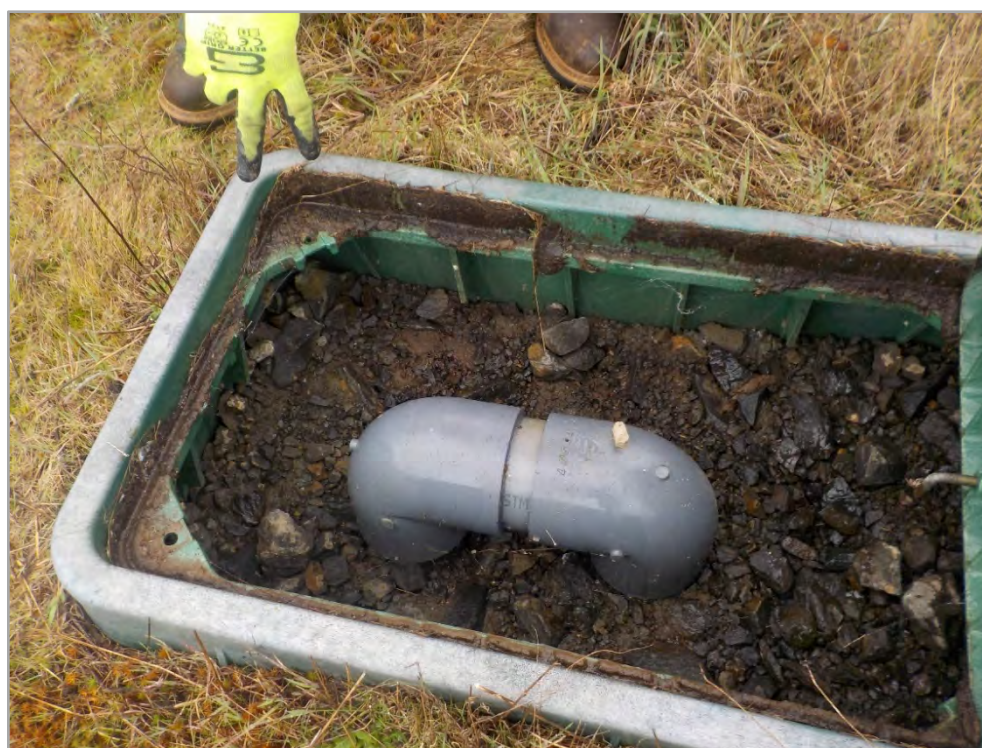
**Photograph A8:** Gas vent GV-2 with intact vault (March 2019).

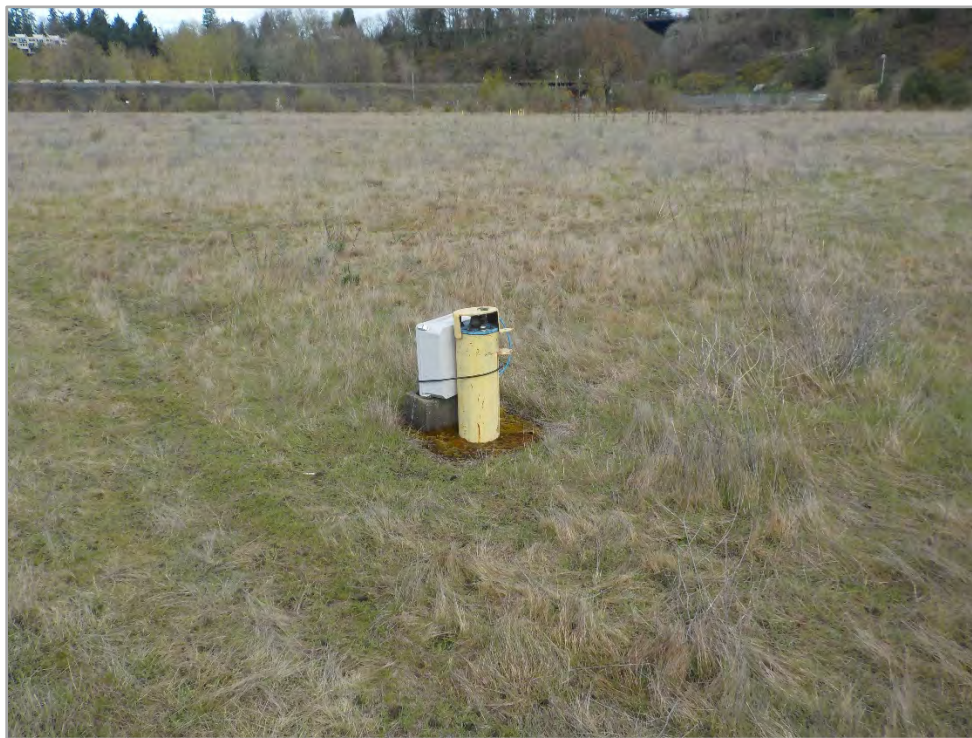
**Photograph A10:** Impermeable Cap vegetative cover conditions in vicinity of EW-1s. View facing north (April 2019).

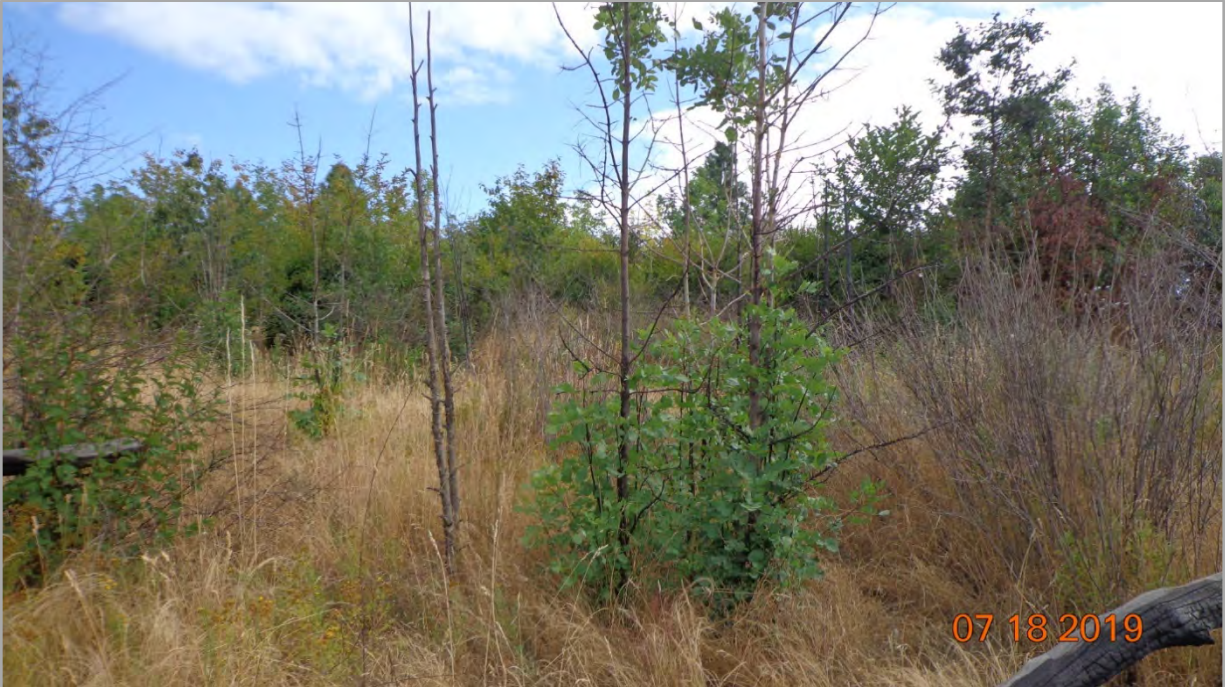
**Photograph A13:** New growth on trees within the July 2018 riparian fire burn area. Regrowth of grass groundcover is complete (July 2019).

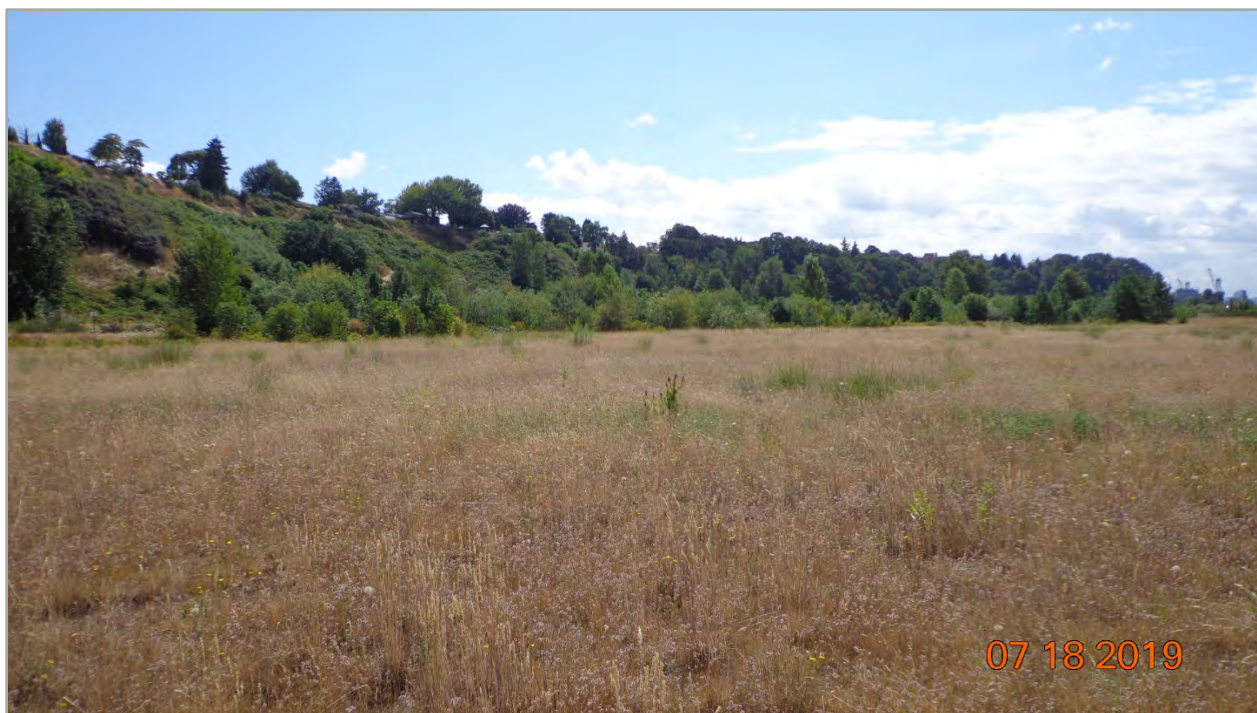
**Photograph A15:** Upland Cap area cover vegetation conditions (July 2019).

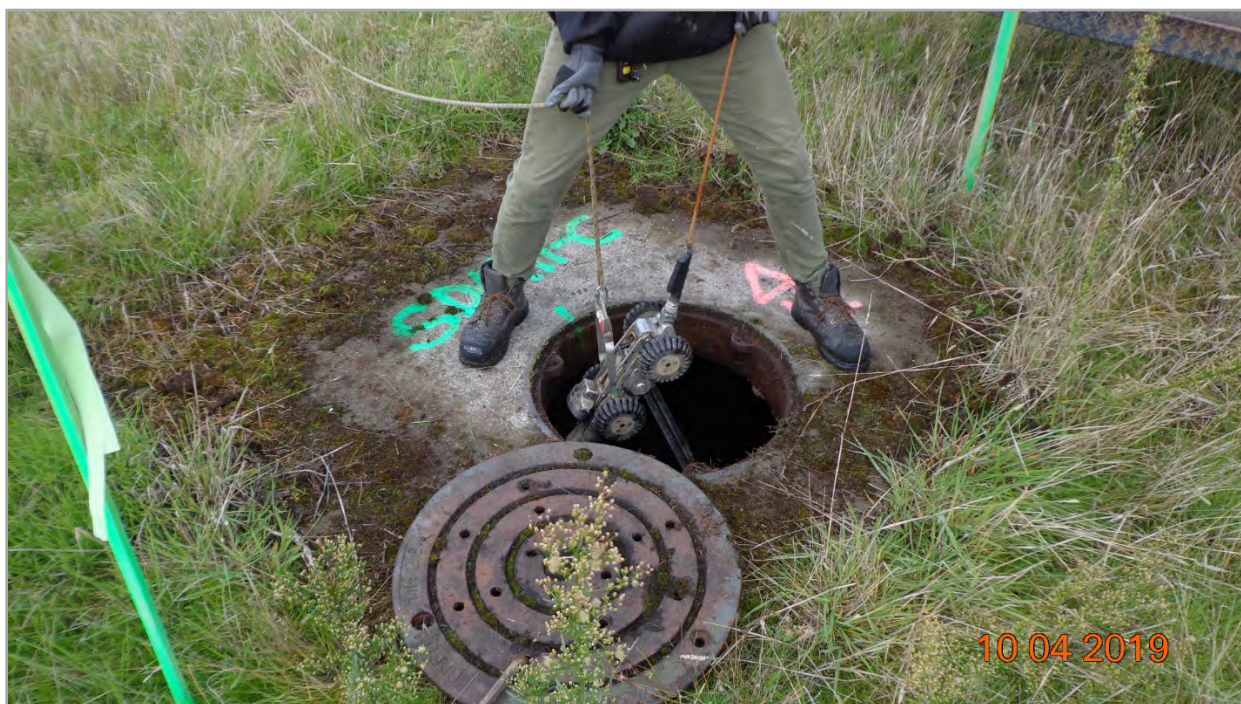
**Photograph A18:** Video inspection of the storm sewer using a robotic crawler. Crawler is being lowered into manhole SDMH-C (October 2019).

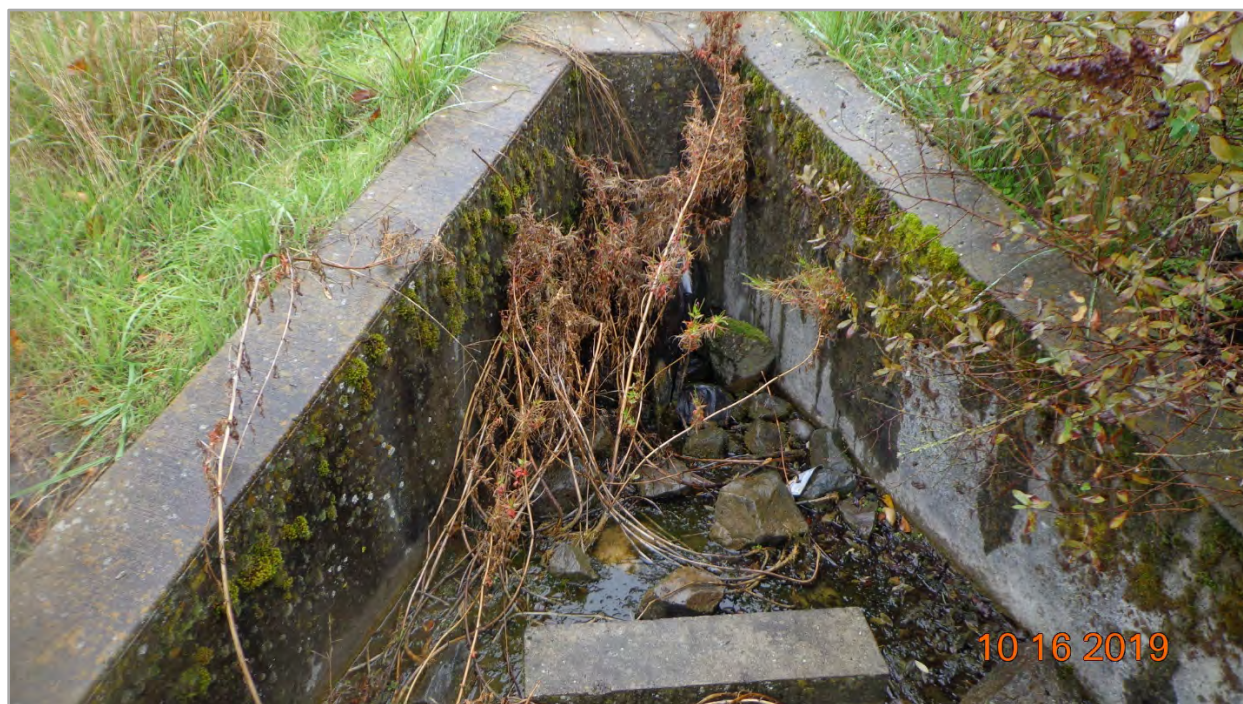
**Photograph A20:** Water drainage of less than 1 gallon per minute from the storm sewer outfall (October 2019).

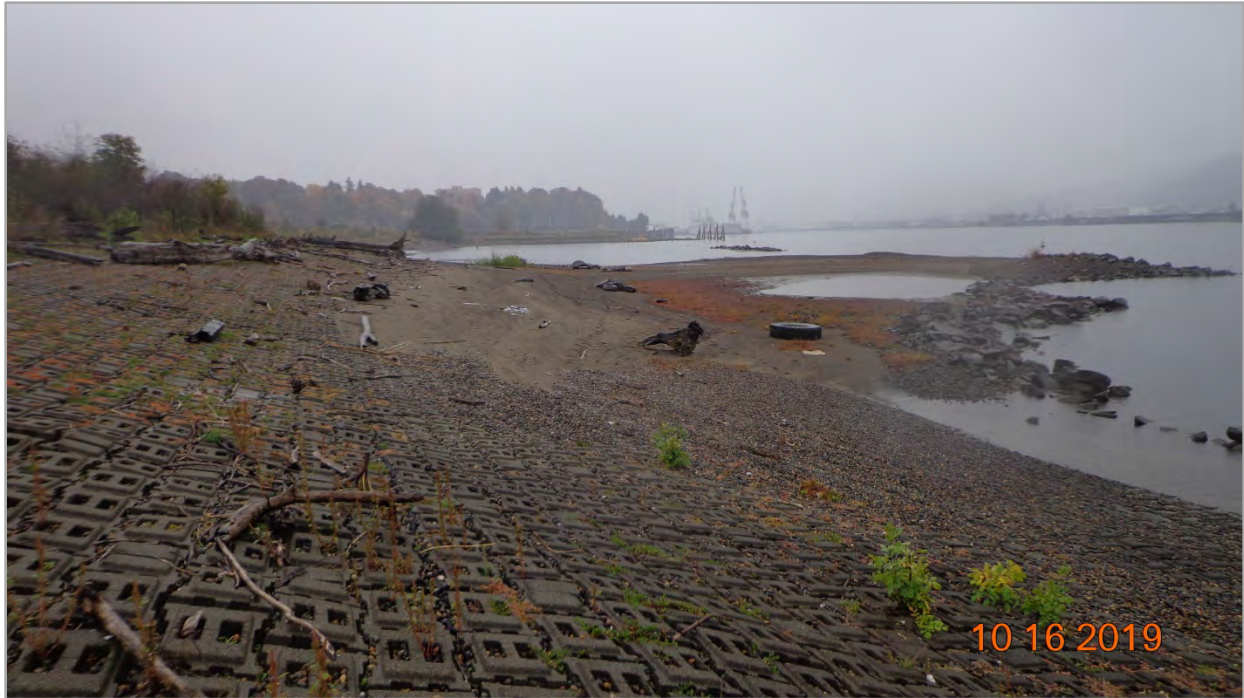
**Photograph A21:** Willamette River Shoreline during low tide in the vicinity of MW-39 well cluster facing southeast (October 2019). Driftwood and several items of trash visible, including a heavy equipment tire. Cover gravel washed down from the upper slope of the ACB is visible lower on the ACB slope.

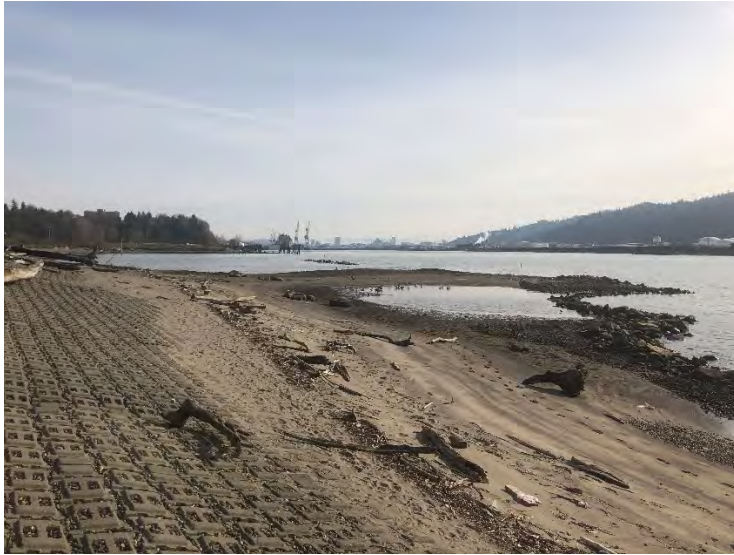
The September 2017 shoreline ACB repairs continue to appear to be in good condition and will be monitored throughout the year. Wildlife (geese, seagulls) were observed along the Willamette River shoreline during site walk (Photo 1).

Photo 1 –View of the bird wildlife along the Willamette River Shoreline.

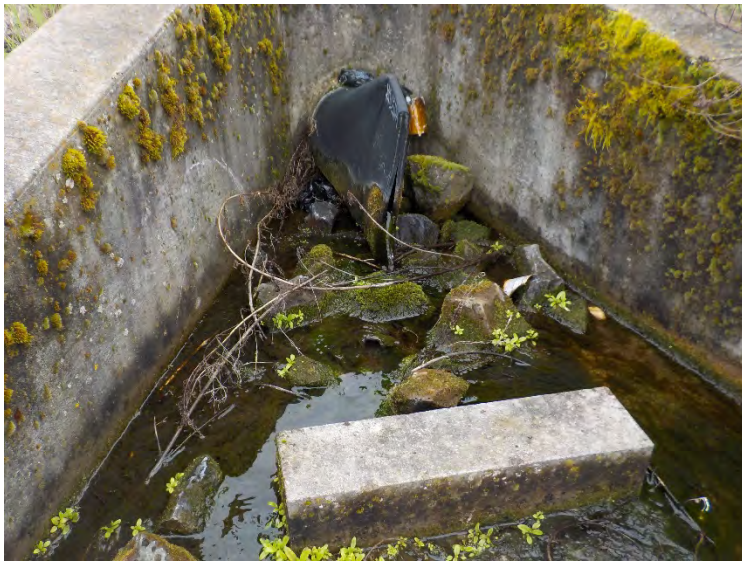
Photo 4 –View of stormwater discharge outfall at approximately 5 gallons per minute.

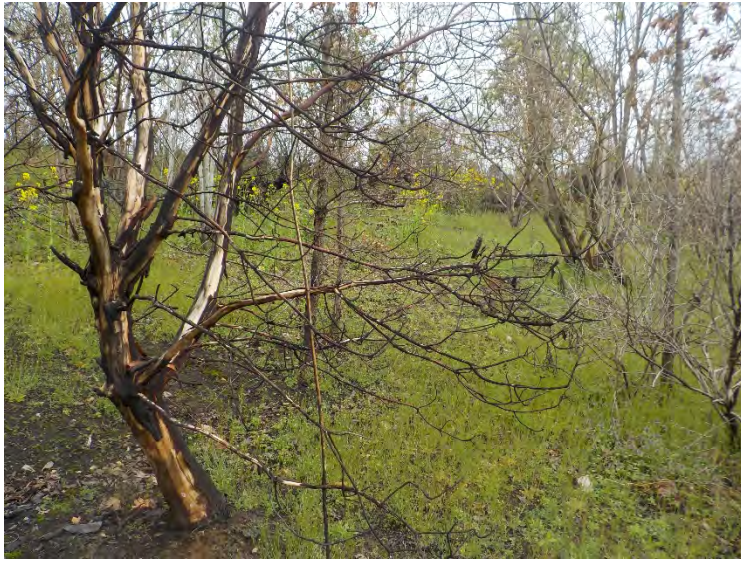
Photo 5 –View of returning vegetation in the riparian area after the fire in August 2018.

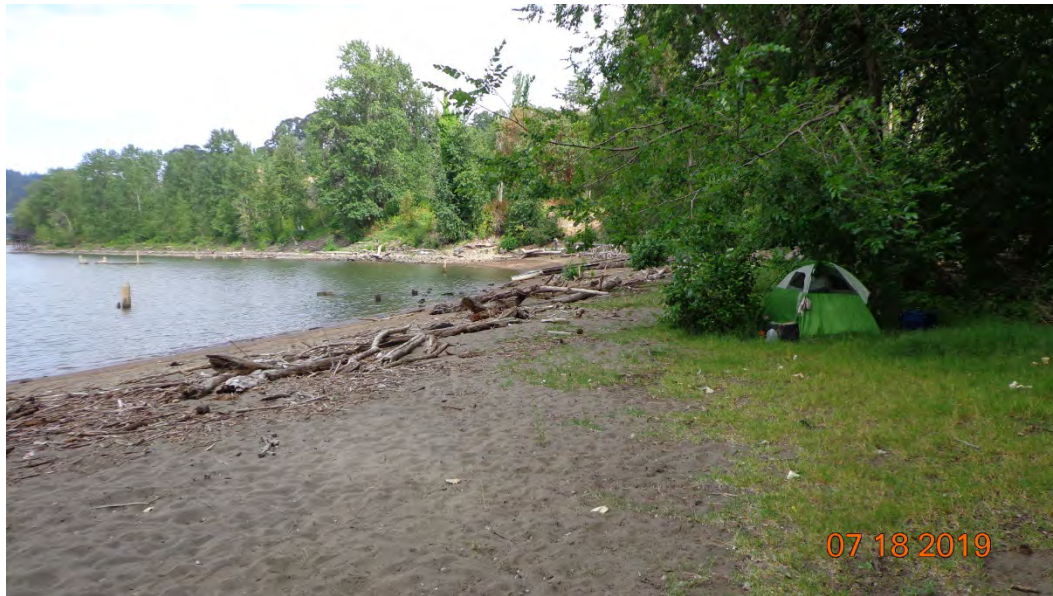
Four derelict boats anchored in Willamette Cove during previous site inspections were observed to still be present. None appeared to be anchored on the ACB shoreline of Willamette cove. A single tent was observed just north of the pathway leading down to Willamette Cove parallel to the Burlington Northern rail line (Photo 1). The area around the tent will continue to be monitored for signs of further encampment and potential trash/ debris dumping. No other trash, dump sites, or homeless encampments were observed. As the inspection progressed along the riparian area shoreline, a fishing boat with two occupants were observed fishing just outside the buoys in the Willamette River (Photo 2).

Photo 1 –View of  
encampment along Willamette  
Cove shoreline

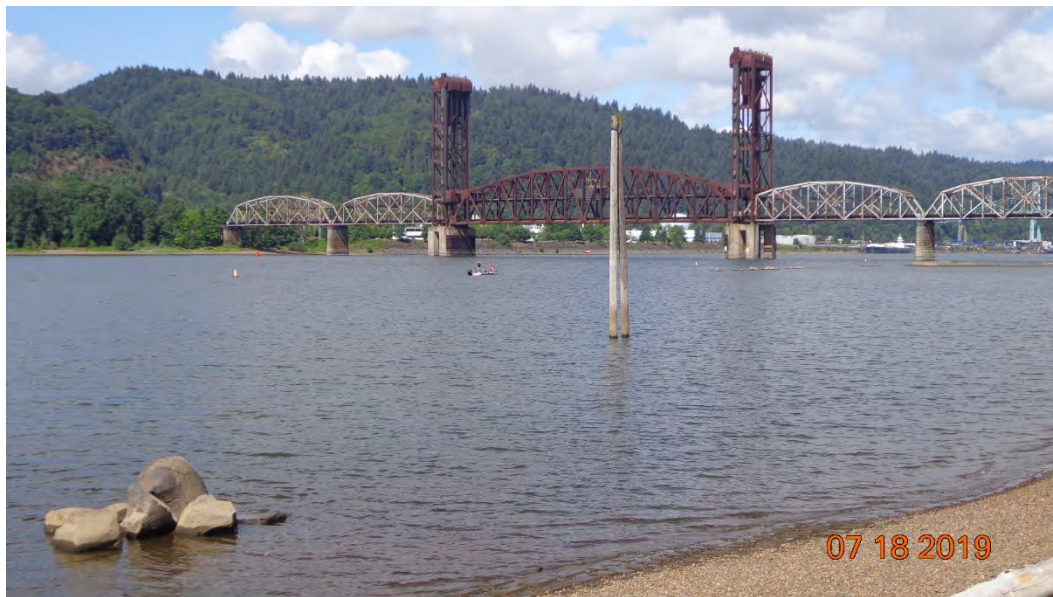
Photo 2 –View of fisherman  
fishing outside buoy boundary  
on Willamette River

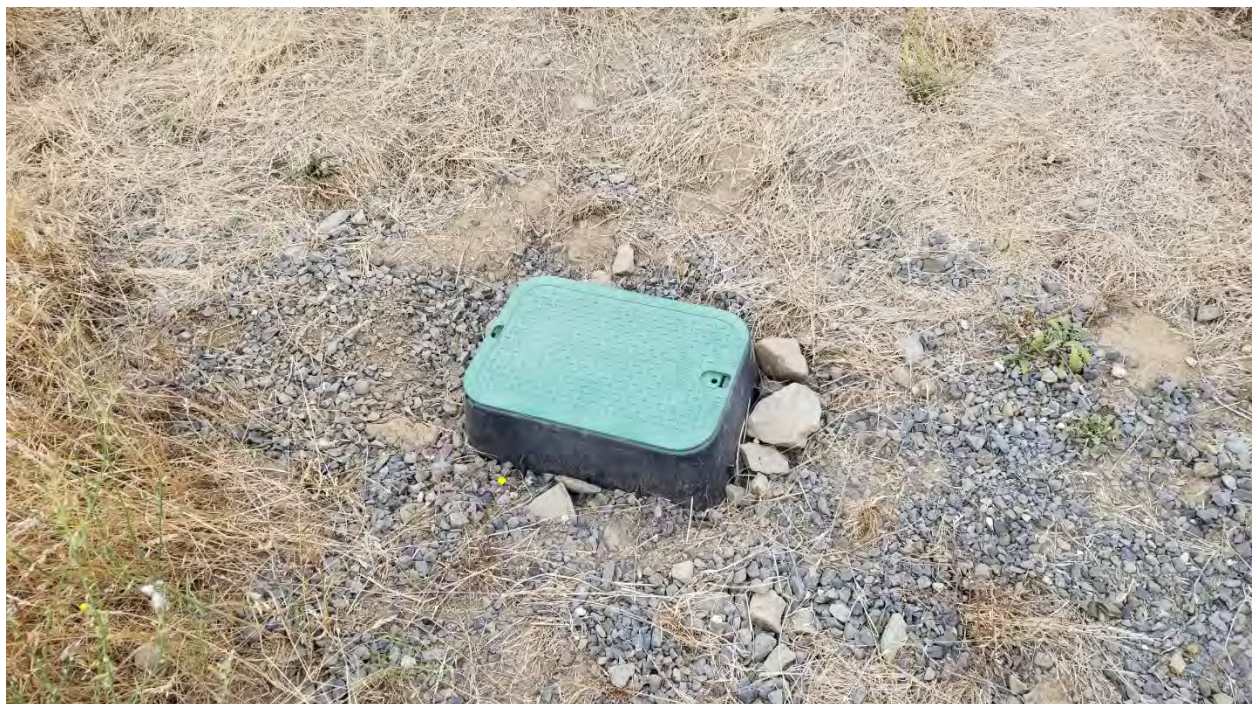
Photo 4: View of gas vent G-1.

Gas vents G-1, G3, and G-4 were inspected as they were not inspected during the last site inspection as planned. None of the inspection personnel had a map with the exact location of the gas vents and they had to be located in the field. Personnel found gas vents gas vents G-3, G-4, and G-1 at which point heavy rain began to fall so the inspection was concluded. Photos of the gas vents are included as Photo 4 to 7 taken on August 21, 2019, are included to document that vault boxes had additional soil placed to stabilize the vault box (G-2 and G-3) or that the vault box was replaced entirely (G-1 and G-4). Site maps currently list two probes as G-3. Based on the apparent clockwise order the gas vents are labeled as G-1 in the NW corner, G-3 in both the NE and SE corner, and G-4 in the SW corner, it is concluded that the label for G-3 in the NE corner should be G-2 and will be revised accordingly.

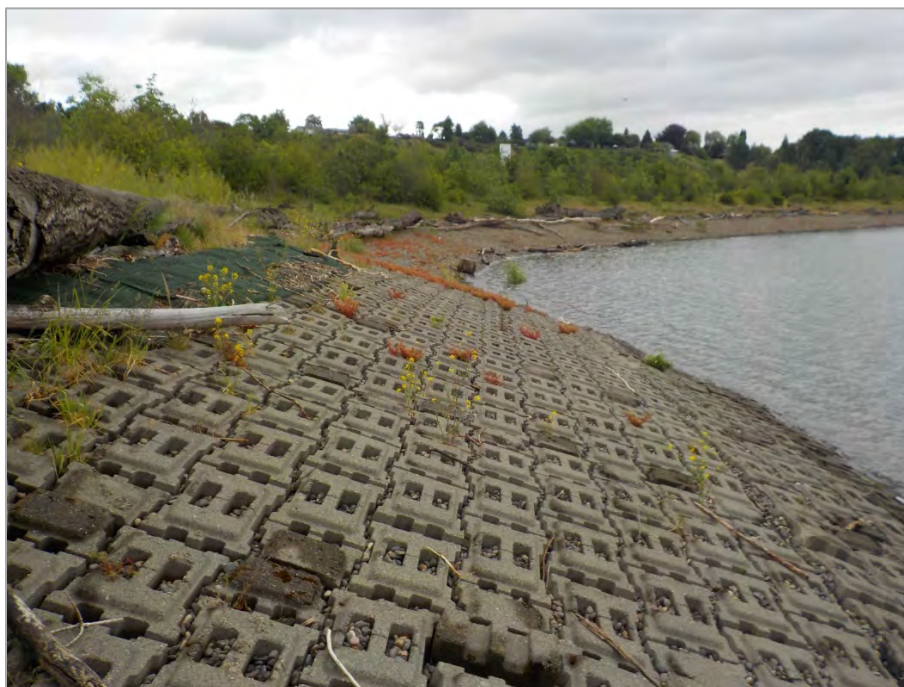
**Photograph C14:** Vegetation growth and wood debris within the lower riparian component and along the shoreline. Taken looking southeast from Photograph Station 7 comparing baseline and current conditions (May 2019).

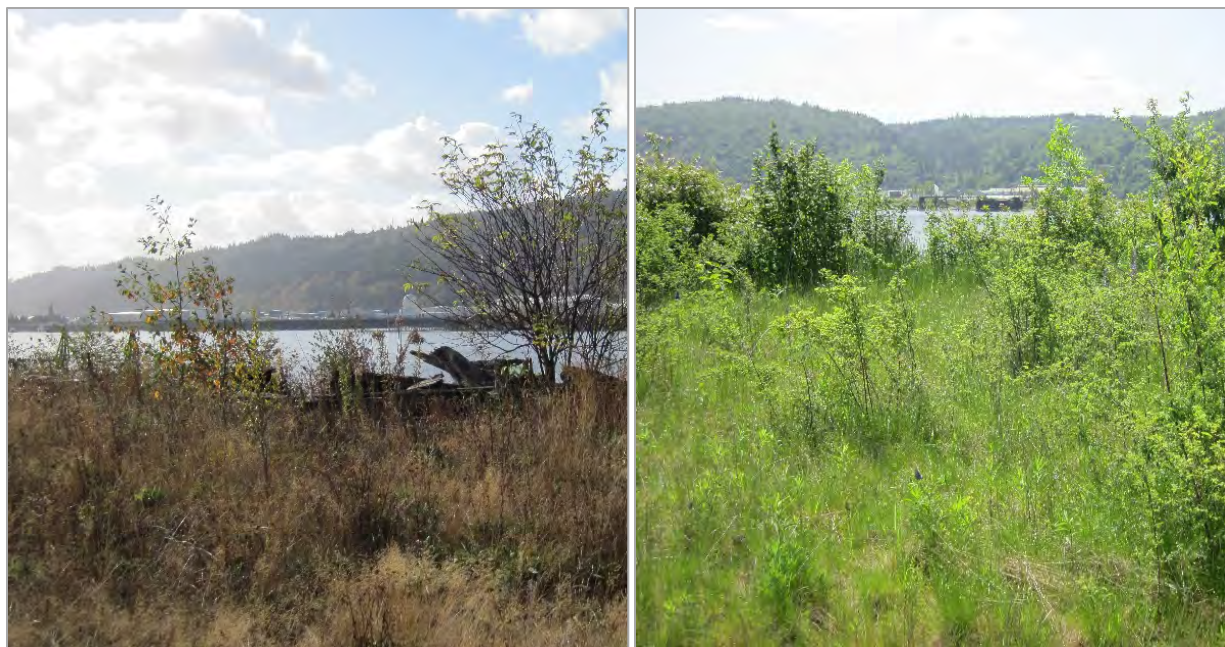
**Photograph C15:** Upper riparian component with trees, shrubs, and herbaceous plants. Taken from Photograph Station 8 looking southwest (Left – May 2012; right – October 2012).

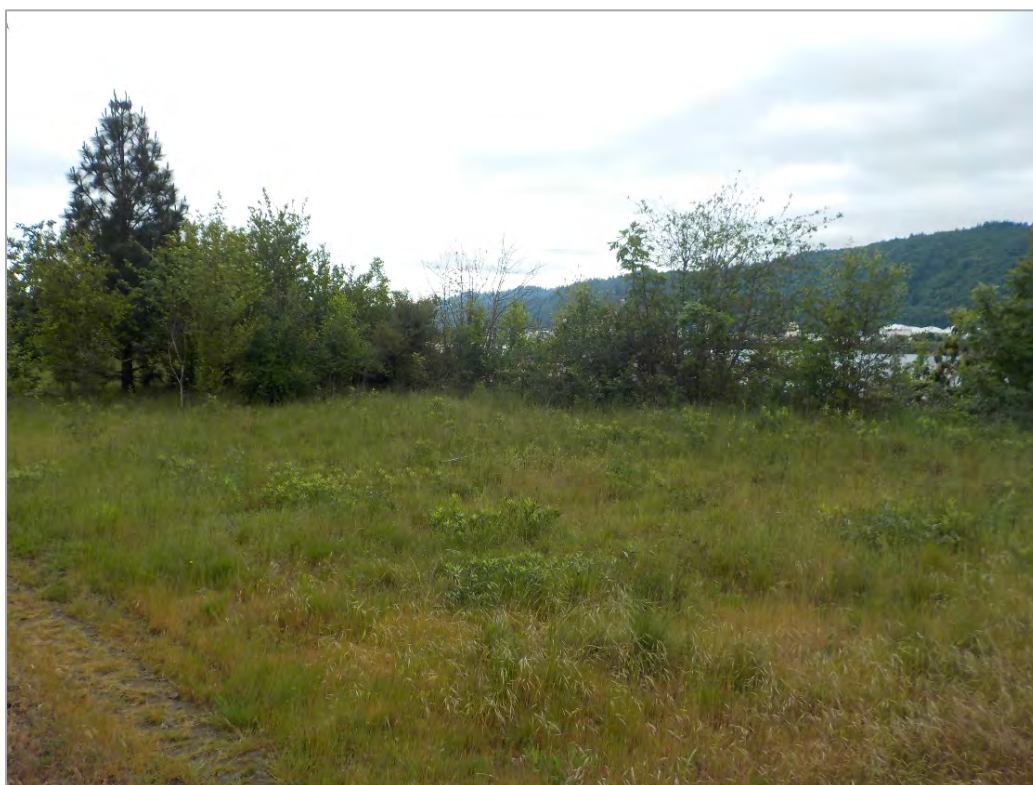
**Photograph C16:** Upper riparian component with trees, shrubs, and herbaceous plants. Taken from Photograph Station 8 looking southwest (May 2019).

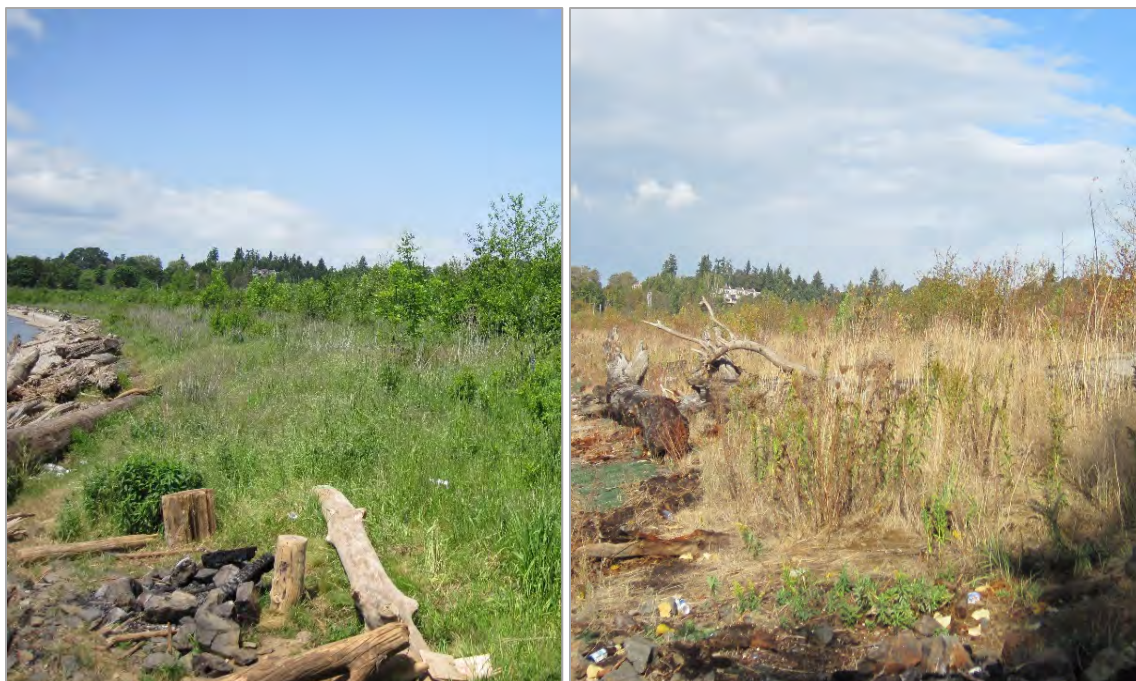
**Photograph C17:** Lower riparian component with large wood along the edge. Taken from Photograph Station 9 looking northwest (Left – May 2012; right – October 2012).

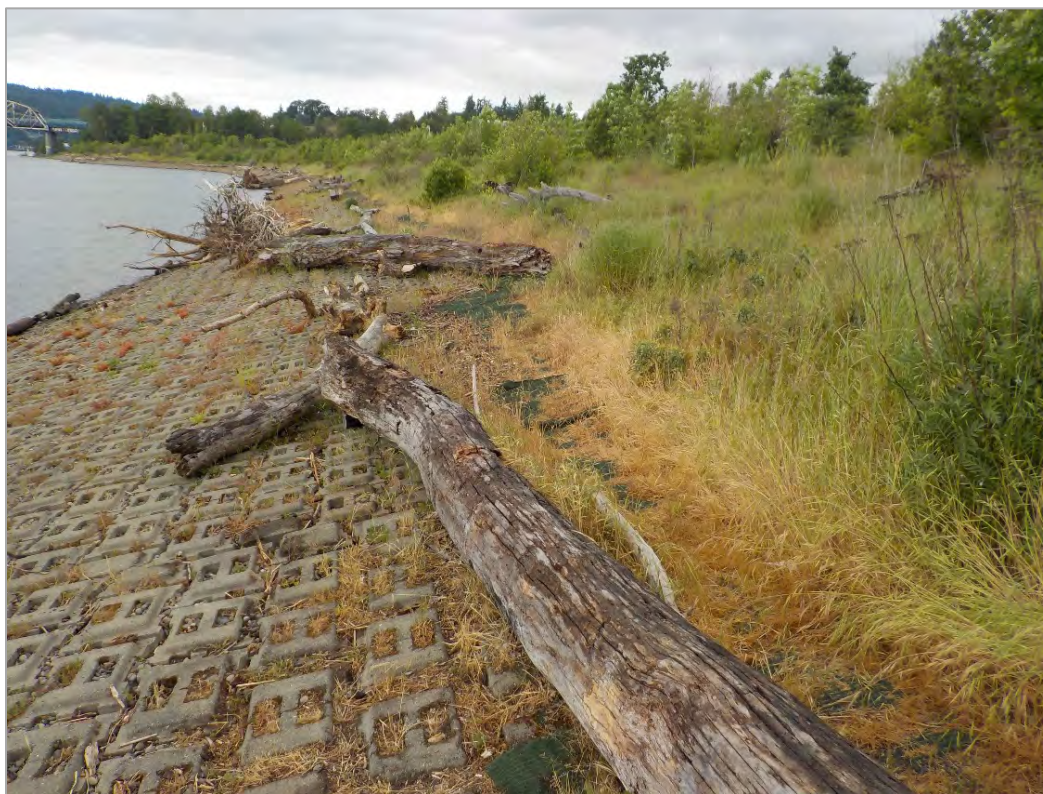
**Photograph C18:** Lower riparian component with large wood along the edge. Taken from Photograph Station 9 looking northwest (May 2019).
